## **Release Notes for DrayTek Vigor2620 series (UK/Ireland)**

Firmware Version	3.9.8.6 BT (Formal Release)
Release Type	<b>Regular</b> – Upgrade recommended when convenient
Release Date	21 <sup>st</sup> September 2023
Build Date	30 <sup>th</sup> August 2023
Revision	17593_1125
Applicable Models	Vigor 2620Ln
VDSL Modem Code	576D17
ADSL Modem Code	572801
Locale	UK & Ireland Only

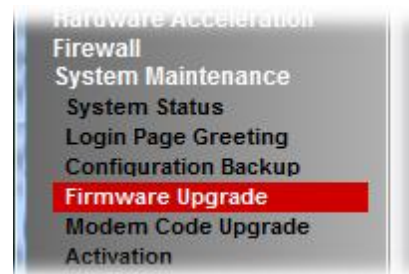
To upgrade firmware, select '*firmware upgrade*' from the router's system maintenance menu and select the correct file. Ensure that you select the ALL file unless you want to wipe out your router's settings back to factory default.

It is recommended that you take a configuration backup prior to upgrading the firmware. This can be done from the router's system maintenance menu.
