## **Release Notes for DrayTek Vigor 2962 (UK/Ireland)**

Firmware Version	4.4.5.1 – Mainline branch (Formal Release)
Release Type	<b>Critical</b> – Upgrade recommended immediately
Build Date	6 <sup>th</sup> August 2025
Release Date	11 <sup>th</sup> September 2025
Revision	5232_8190_6a81e90581
Applicable Models	Vigor 2962
Locale	UK & Ireland Only

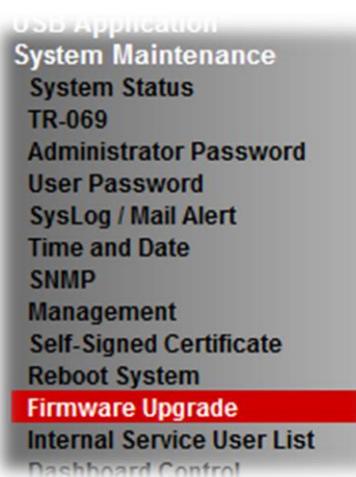
To upgrade firmware, select '*firmware upgrade*' from the router's system maintenance menu and select the correct file. Ensure that you select the ALL file unless you want to wipe out your router's settings back to factory default.

It is recommended that you take a configuration backup prior to upgrading the firmware. This can be done from the router's system maintenance menu.
