Release Notes for DrayTek Vigor 2962 (UK/Ireland)

Firmware Version	4.4.3.8 – Stable branch (Formal Release)
Release Type	Important – Review release notes and upgrade if the changes affect your system stability, performance, or security
Build Date	11 th December 2025
Release Date	23 rd December 2025
Revision	5041_7741_5b232b73ab
Applicable Models	Vigor 2962
Locale	UK & Ireland Only

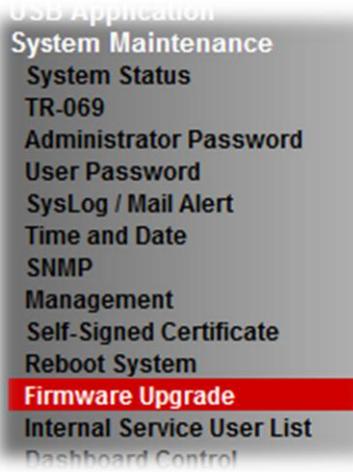
To upgrade firmware, select '*firmware upgrade*' from the router's system maintenance menu and select the correct file. Ensure that you select the ALL file unless you want to wipe out your router's settings back to factory default.
