Release Notes for DrayTek Vigor 3220 (UK/Ireland)

Firmware Version	3.9.8.1 (Formal Release)
Release Type	Critical – Upgrade recommended immediately
Build Date	8th January 2024
Release Date	12th January 2024
Revision	19660_1139_62678ecf3c
Applicable Models	Vigor 3220
Locale	UK Only

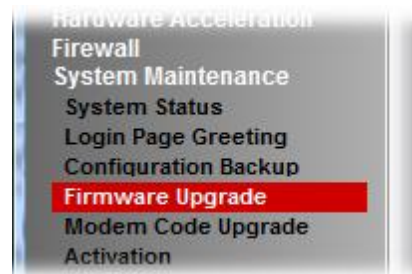
To upgrade firmware, select '*firmware upgrade*' from the router's system maintenance menu and select the correct file. Ensure that you select the ALL file unless you want to wipe out your router's settings back to factory default.

It is recommended that you take a configuration backup prior to upgrading the firmware. This can be done from the router's system maintenance menu.
