## Release Notes for DrayTek Vigor 3910 (UK/Ireland)

Firmware Version	4.4.3.7 – Stable branch (Formal Release)
Release Type	<b>Important</b> – Review release notes and upgrade if the changes affect your system stability, performance, or security
Build Date	4 <sup>th</sup> November 2025
Release Date	18 <sup>th</sup> December 2025
Revision	5032_7733_fe0c8ec42f
Applicable Models	Vigor 3910
Locale	UK & Ireland Only

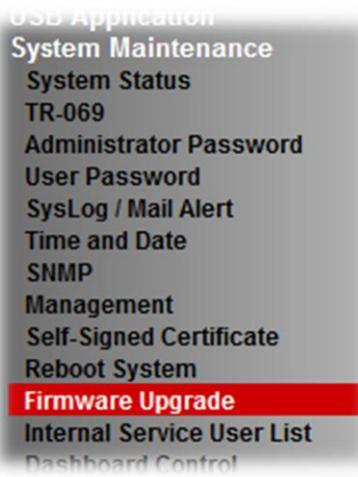
To upgrade firmware, select '*firmware upgrade*' from the router's system maintenance menu and select the correct file. Ensure that you select the ALL file unless you want to wipe out your router's settings back to factory default.
