Release Notes for DrayTek Vigor 3910 (UK/Ireland)

Firmware Version	4.4.3.8 – Stable branch (Formal Release)
Release Type	Important – Review release notes and upgrade if the changes affect your system stability, performance, or security
Build Date	11 th December 2025
Release Date	23 rd December 2025
Revision	5041_7741_5b232b73ab
Applicable Models	Vigor 3910
Locale	UK & Ireland Only

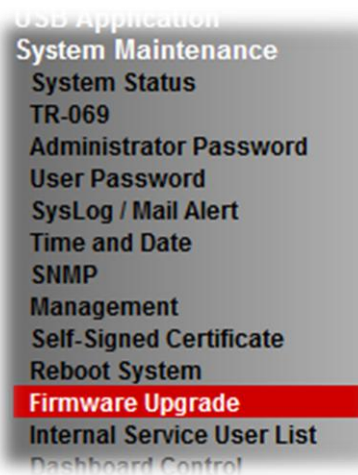
To upgrade firmware, select '*firmware upgrade*' from the router's system maintenance menu and select the correct file. Ensure that you select the ALL file unless you want to wipe out your router's settings back to factory default.
