Release Notes for DrayTek Vigor 3912 (UK/Ireland)

Firmware Version	4.4.5.1 – Mainline branch (Formal Release)
Release Type	Critical – Upgrade recommended immediately
Build Date	6 th August 2025
Release Date	11 th September 2025
Revision	5232_8190_6a81e90581
Applicable Models	Vigor 3912, Vigor 3912S
Locale	UK & Ireland Only

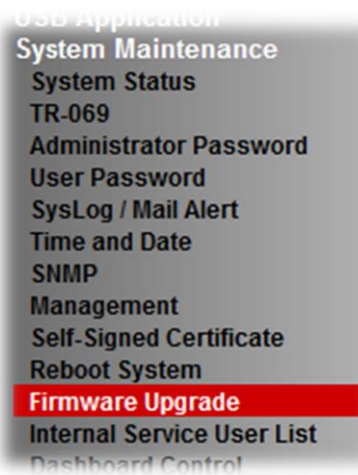
To upgrade firmware, select '*firmware upgrade*' from the router's system maintenance menu and select the correct file. Ensure that you select the SFW file unless you want to wipe out your router's settings back to factory default.
